## Sustainable technology case study

Installation of solar thermal units to provide hot water to flats  
January 2010

Solar thermal | Hanbury Hall

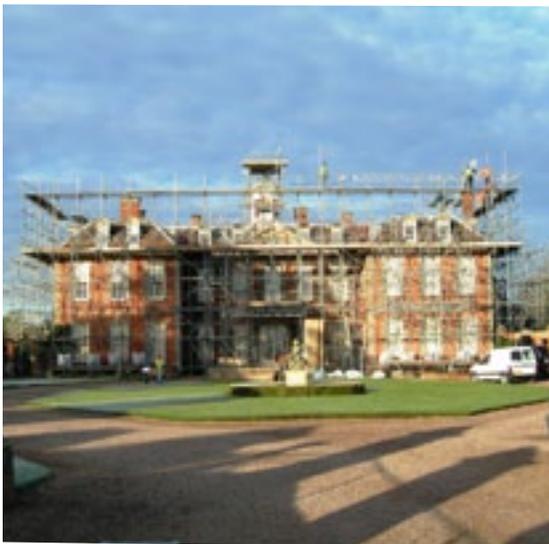
Far left Hanbury Hall during the re-roofing works

■ The work was undertaken during the roof replacement project allowing access to the space under the roof for running pipes and connectors. The solar collectors were then installed as the lead roof was put back into place. This greatly minimised the additional work that could have been incurred.

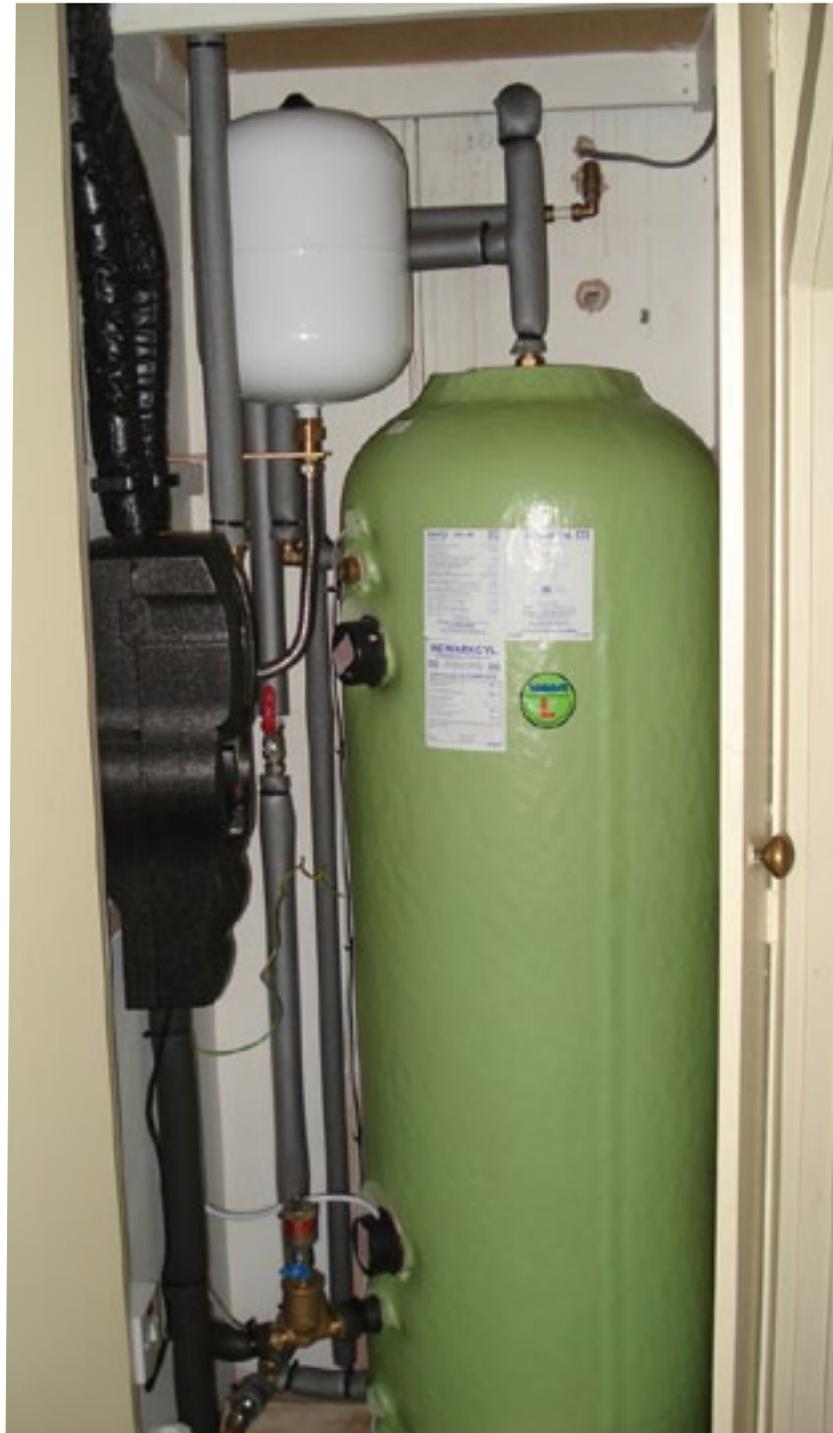
Left Solar thermal tank

■ The units at Hanbury Hall performed well after commissioning but produced lower levels of hot water than expected. This volume of water was not considered sufficient for day to day living in the flats. The immersion elements were removed from the tops of the cylinders and placed further down to enable larger volumes of water to be heated.

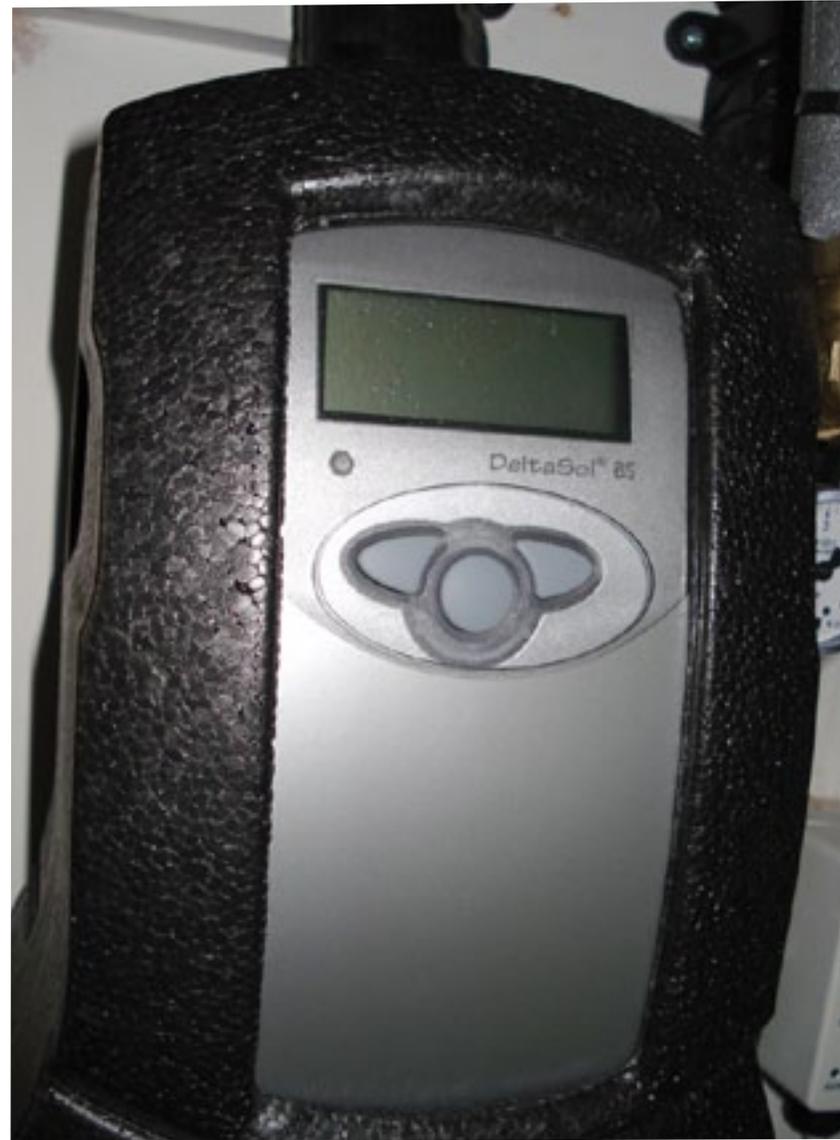
**Above Deltasol digital controls**

■ The installation consists of four separate flat plate solar thermal systems. Each with two solar collectors, pipes, expansion vessels, a storage tank and Deltasol digital controls. The systems were installed in two stages in order to accommodate holiday flat bookings and so as not to disturb guests.

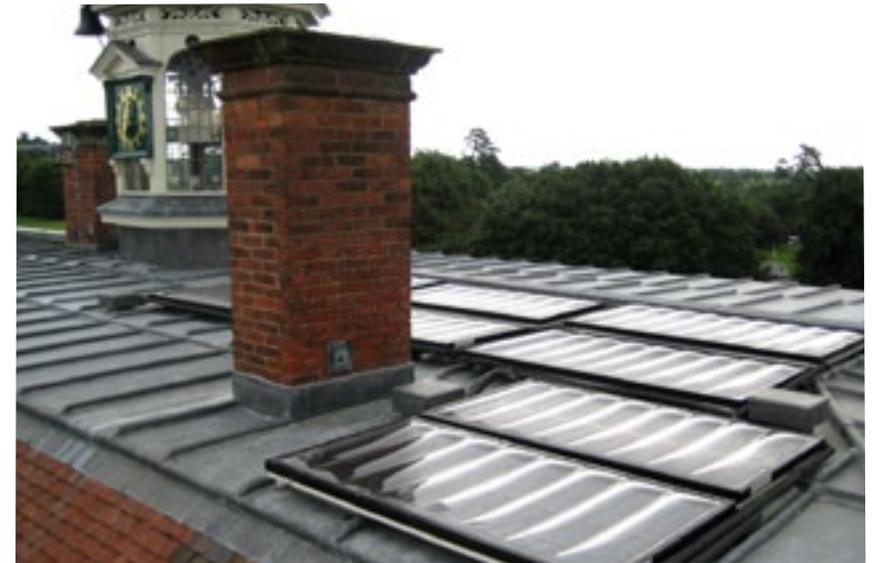
Above right **Solar thermal installation with the restored dovecote**

■ The mock-up timbers had been 295mm higher than the level of the lead bays, however it was later confirmed that by using 'bespoke' fixing brackets this dimension could be reduced to just 248mm. The four units were ultimately grouped on the north side of the main ridge roll, taking advantage of the height of this roll, plus the fall of the leadwork to partially hide the installation. From ground level the appearance of the house has not noticeably altered.
